Jan/Feb 2006

# K Laser Scanning Katrina-Damaged

>> By Tom  
Greaves

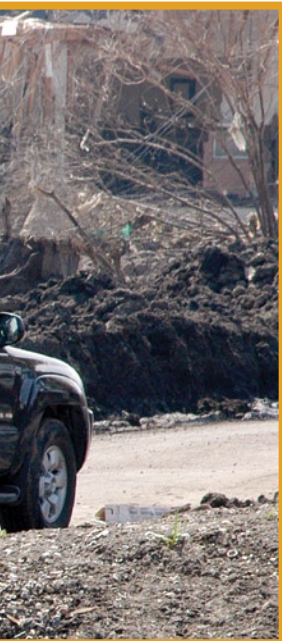
**Facing page:** An unorthodox “tripod” supports a roof-mounted LIDAR unit as Brian Collins scans the 17th Street Canal levee breach. Flowing water flipped cars, floated houses, and created huge debris fields at the levee failures. *Photo: Robert Kayen, USGS, Menlo Park, CA.*

For most of the work, the tripod-mounted Riegl scanner was fixed to a platform on the roof of the field vehicle four meters above the ground. Elevating the scanner to this height reduced shadow zones and extended the coverage area of each scan. Other configurations involved mounting the scanner on its side; for example, toe scour was measured by scanning downward from the top of T-wall sections. Where available, the scanner was set up over existing survey bench marks to geo-reference the data, but in most cases a separate, local coordinate system was required for each site.

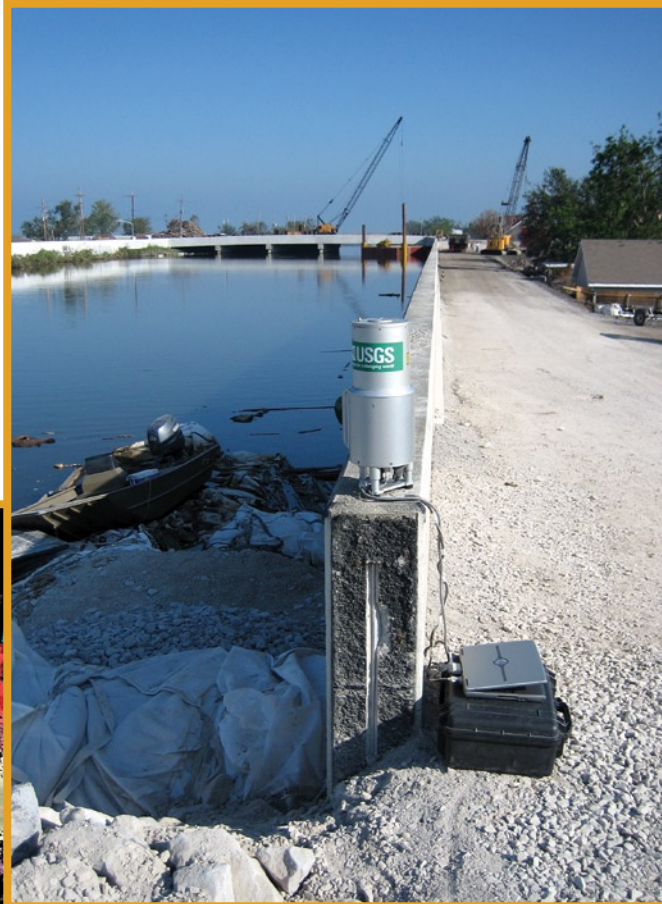
**Above:** LIDAR unit on the edge of intact I-wall levee at the north end of the 17th Street breach.

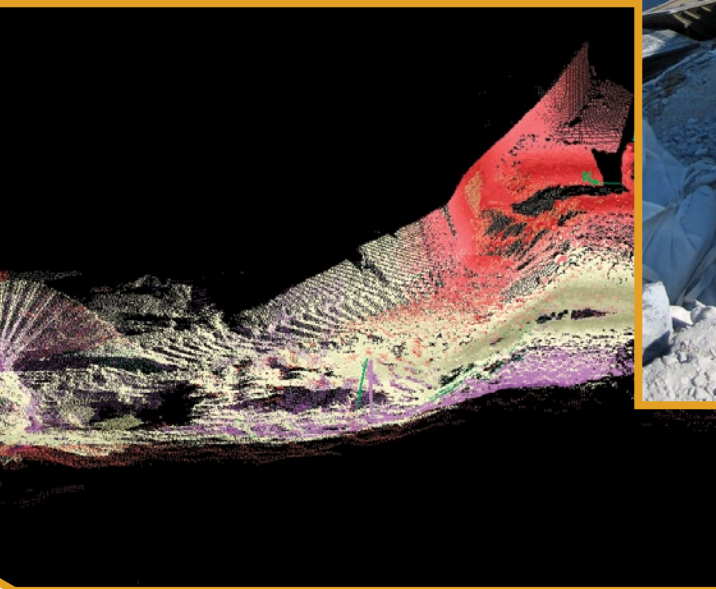
**Left:** Composite LIDAR image of northern levee breach on the Inner Harbor Navigation Canal.

Yet another benefit is that direct measurement of scour trenches allows comparison of scour depth with sheet pile embedment. The data sets, typically 15 to 20 merged scans per site (approximately 2.3 million points per scan), are complete enough to allow cross sections to be extracted in almost any orientation. Capturing the geometry of the surrounding areas provides the investigators rich context for the analysis.

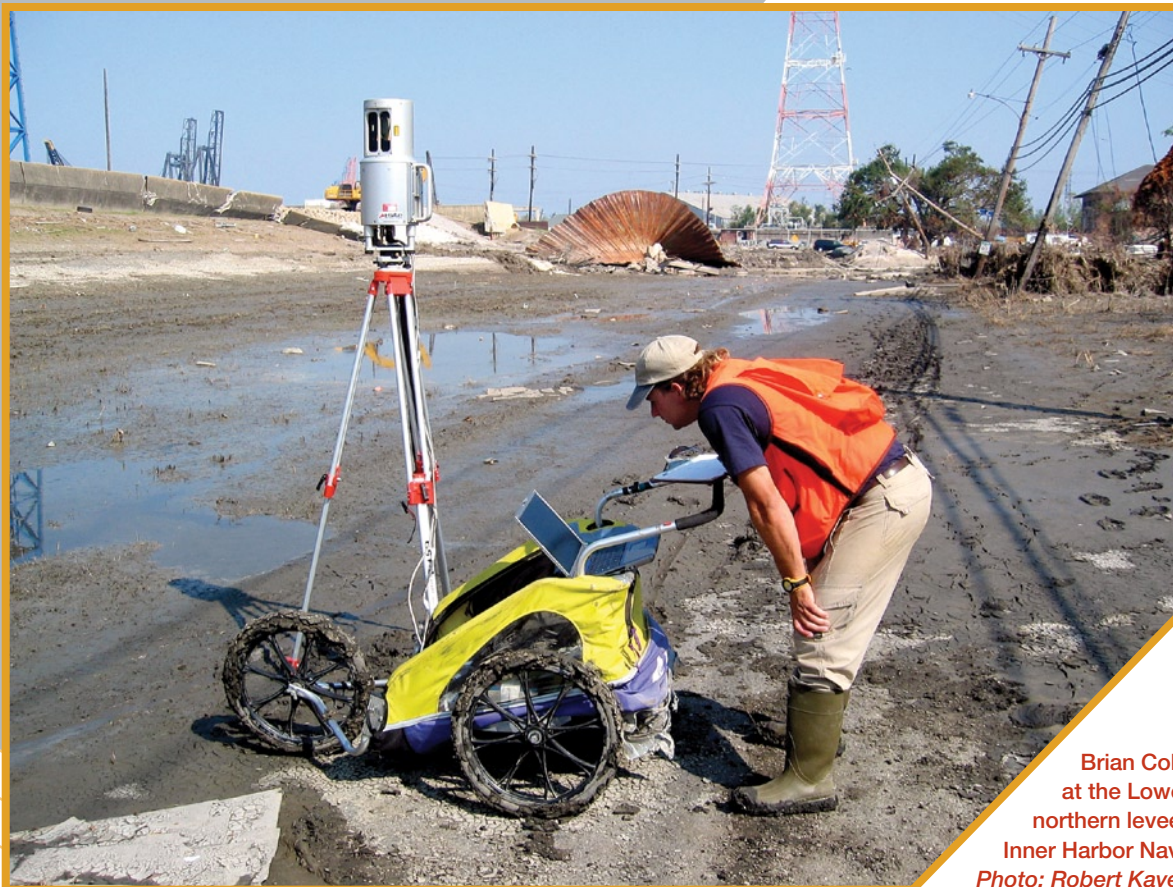
Brian Collins scans at the Lower 9th Ward, northern levee breach on the Inner Harbor Navigation Canal. Photo: Robert Kayen

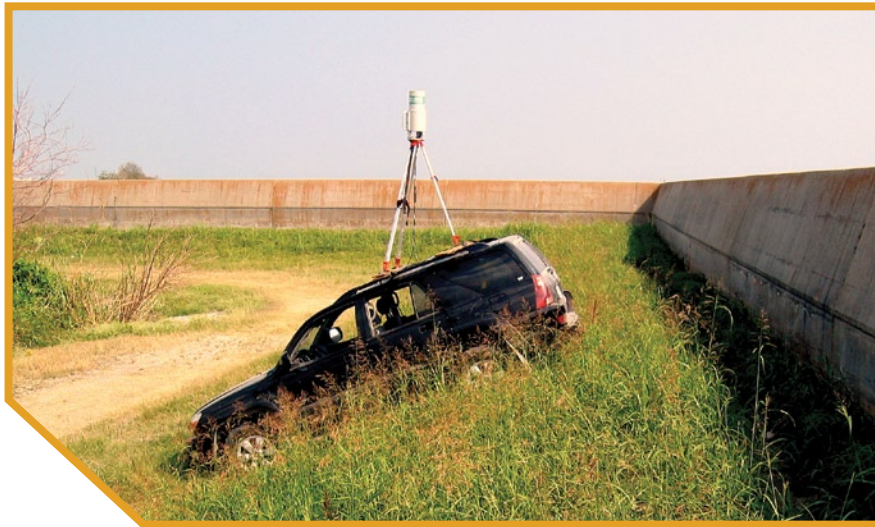
**Left:** Mounted to Kayen and Collins' vehicle, the fixed roof base allowed for the leveling of the tripod and LIDAR instrument on sloping ground. Here the instrument scans scour around the floodwall at an Entergy plant in east New Orleans (survey site 10). *Photo: Robert Kayen*

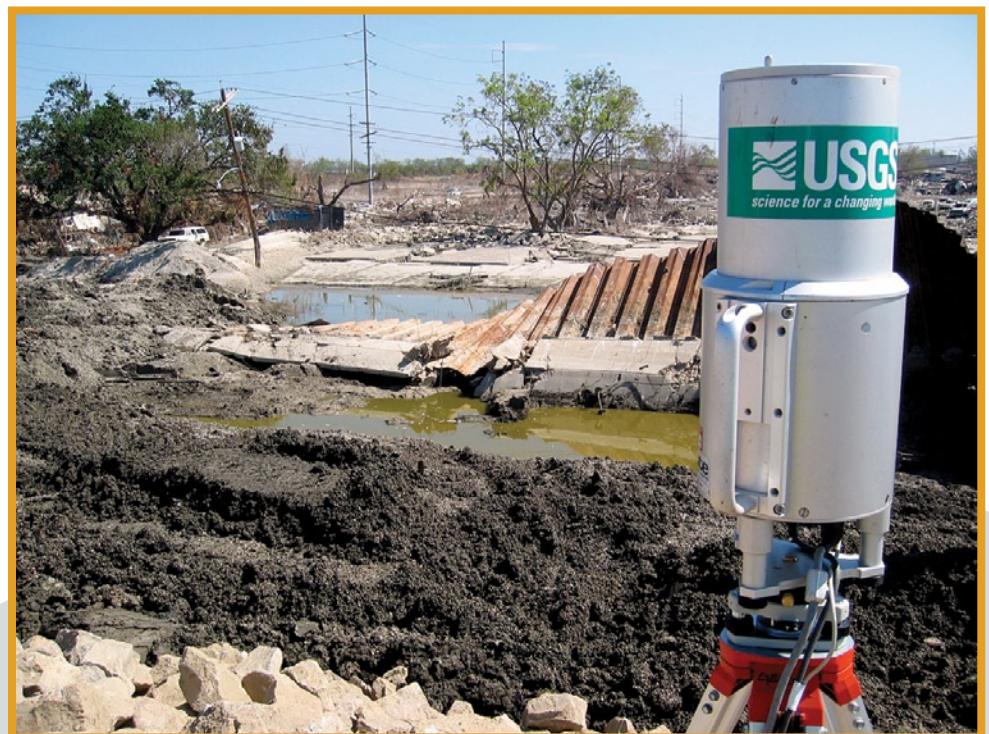
**LIDAR unit at Lower 9th Ward, northern levee breach on the Inner Harbor Navigation Canal. Photo: Robert Kayen**
